Manhole Inspection Summary

Manhole # S55G__038MH

Insp Date: **4/22/08 10:18 AM**

Location Address: **3406 gough street**

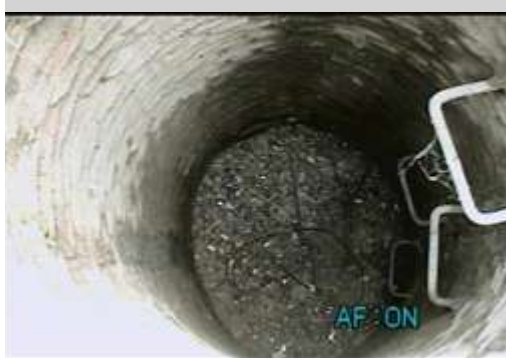
Defect 1

Infiltration: ☐ None ☐ Joint ☐ Cracks ☐ Mortar ☐ Roots ☒ **Wall**

Steps Count: **5** Missing: **0** ☒ **Corroded**

steps; infiltration of barrel wall

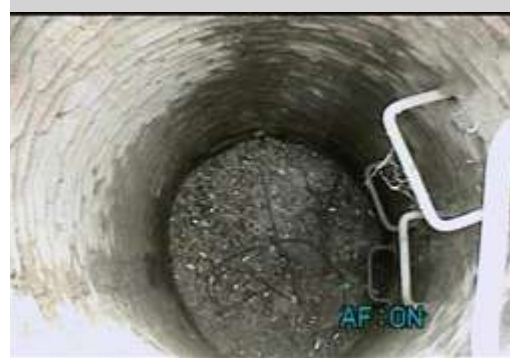
Defect 2

Condition: ☐ Sound ☐ Cracked ☐ Root Intrusion ☐ Deteriorated ☐ Leaks ☒ **Debris**

channel cond debris

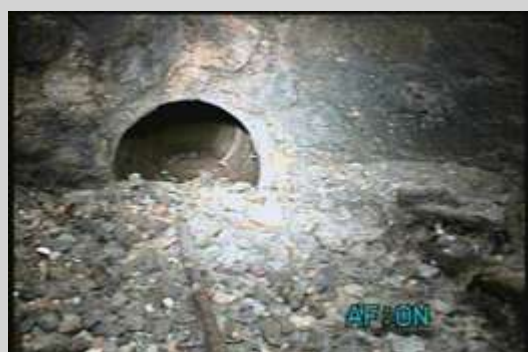
12 O'Clock Outflow

8 in. Circular Gravity Sewer
Pipe Out @ 12 O'Clock

Invert Depth: **8.75** (ft.) Flow Characteristics: **None**

Infiltration: **None** Pipe Seal Cond: **Unknown**
